ANNUAL REPORT FOR 2003

Bethel Church Mitigation Site

Yadkin County

Project No. 6.779004T

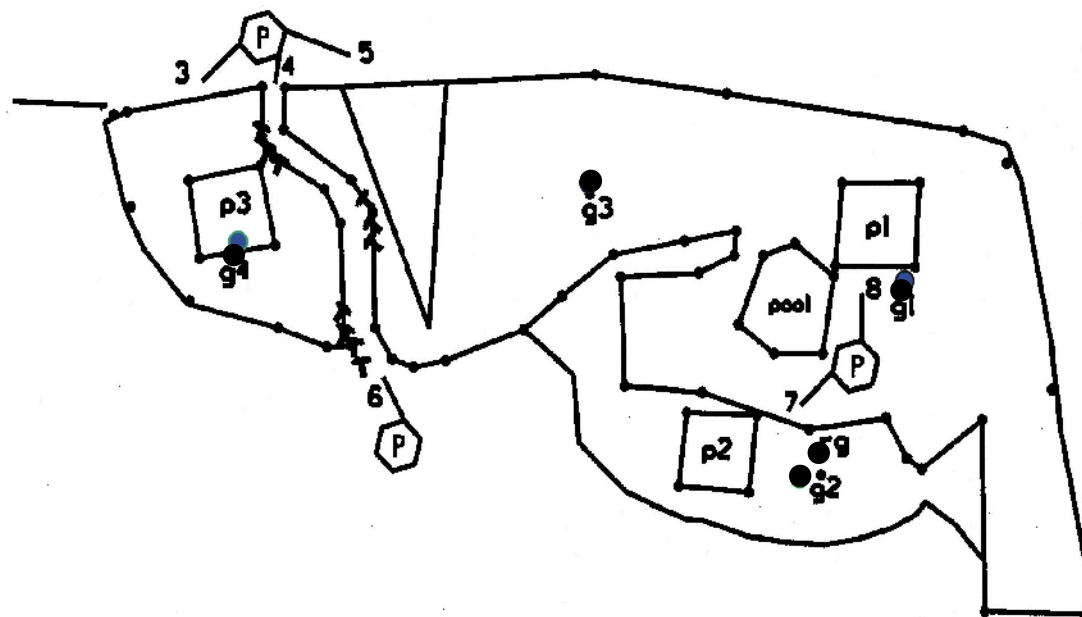
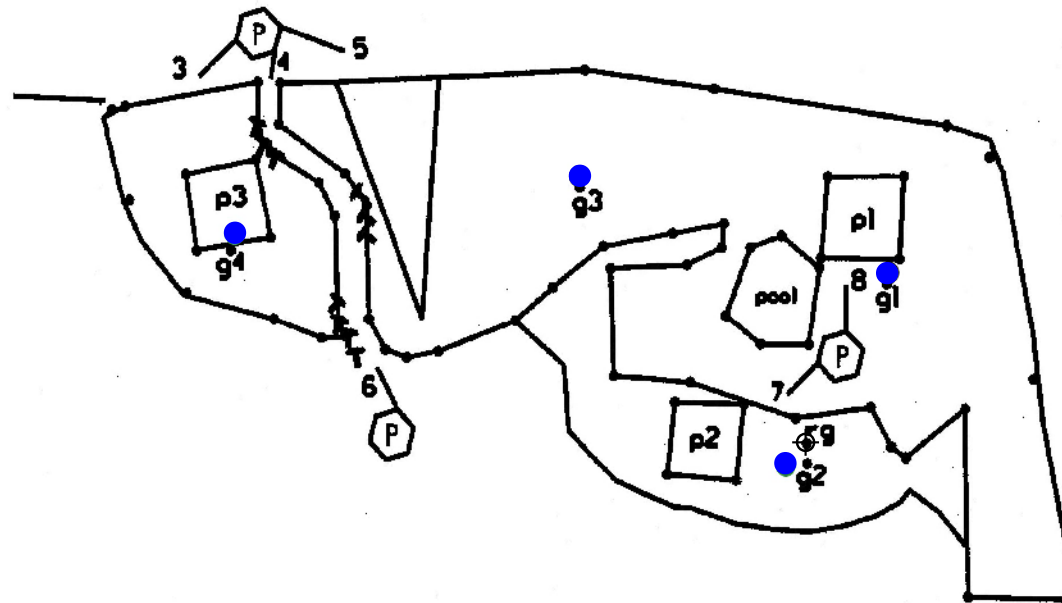
Figure 3. 2003 Hydrologic Monitoring Gauge Results

Figure 3 provides a graphical representation of the hydrologic results. Gauges highlighted in blue indicate wetland hydrology for more than 12.5% of the growing season. Gauges highlighted in green show hydrology between 8% and 12.5% of the growing season. Those gauges highlighted in red indicate wetland hydrology between 5% and 8%.

Monitoring Gauge	<5%	5%-8%	8%-12.5%	>12.5%	Actual %	Success Dates
GW-1				X	48.3	April 9-July 15
GW-2				X	70.4	April 9-August 29
GW-3				X	100	April 9-October 28
GW-4				X	100	April 9-October 28
GW-5				X	100	April 9-October 28
GW-6				X	100	April 9-October 28

- Gauge (GW-1) stopped recording data (July 16-October 29). The gauge was replaced.

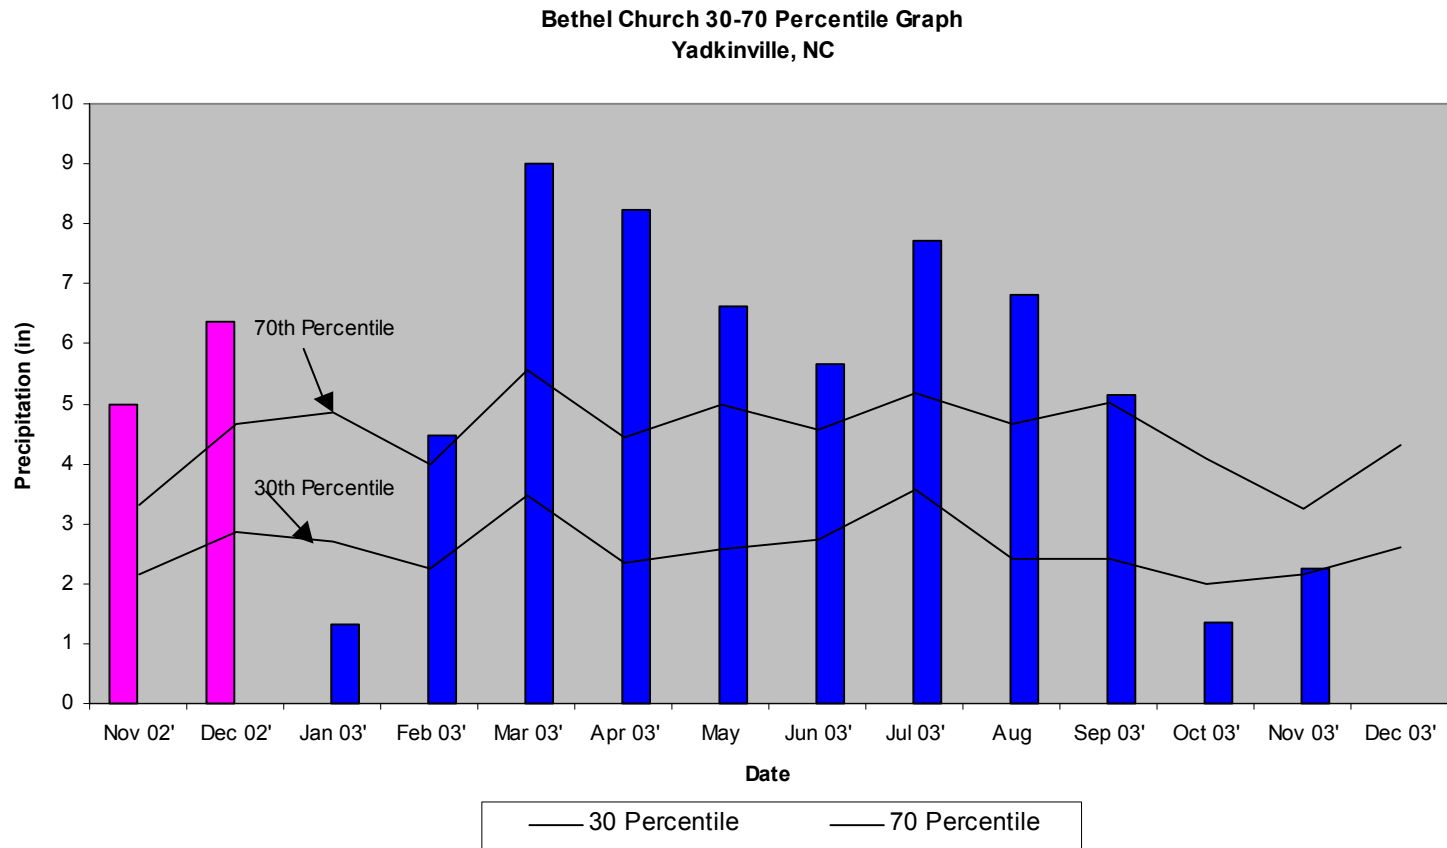
Figure 4: 30-70 Percentile Graph

Figure 4 is a comparison of monthly rainfall for the period of November 2002 through November 2003 to historical precipitation (collected between 1972 and 2003) for Yadkinville, North Carolina. This comparison gives an indication of how 2003 relates to historical data in terms of climate conditions. The NC State Climate Office provided all local rainfall information.

For the 2003-year, November (02'), December (02'), February, March, April, May, June, July, August, and September experienced above average rainfall. The months of January, October, and November recorded below average rainfall for the site. Overall, 2003 experienced an above average rainfall year.

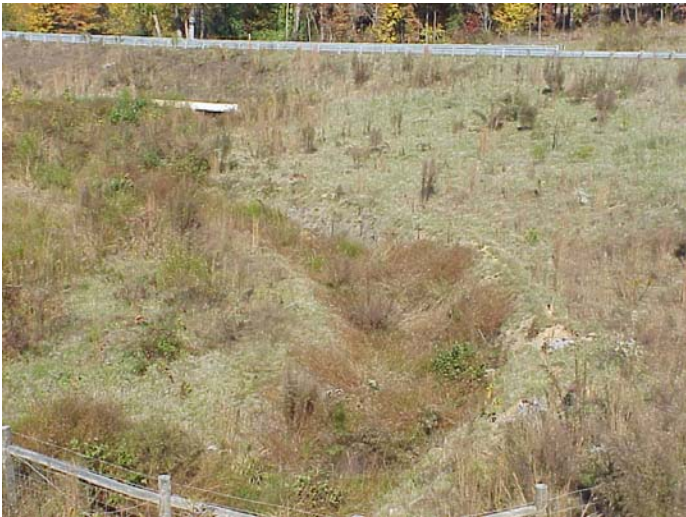
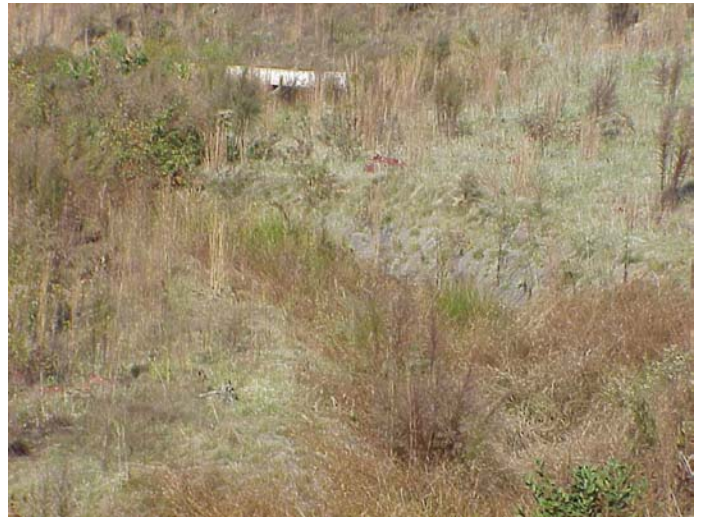
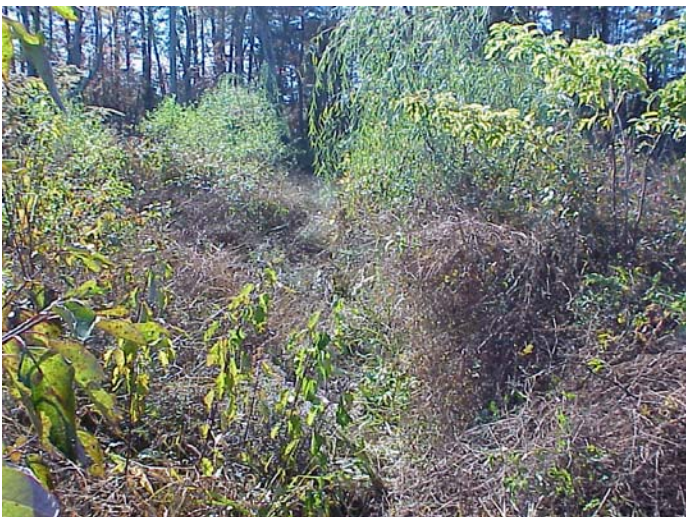
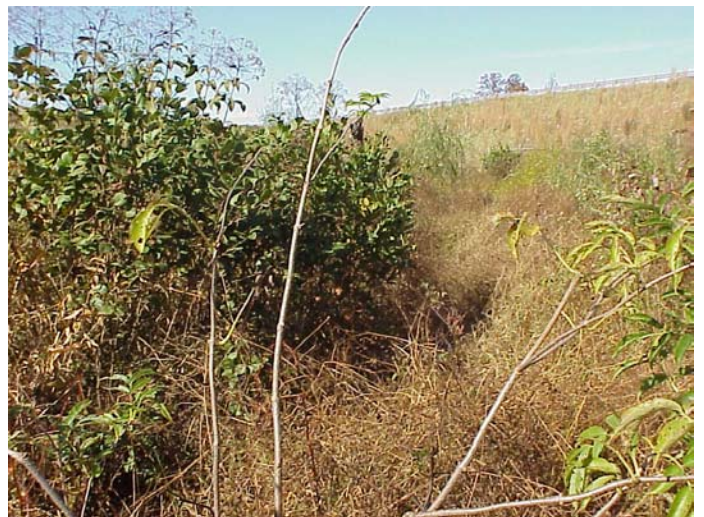
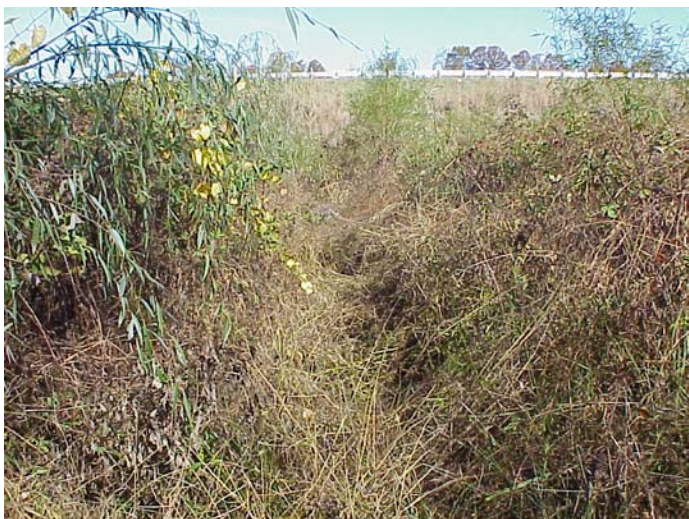
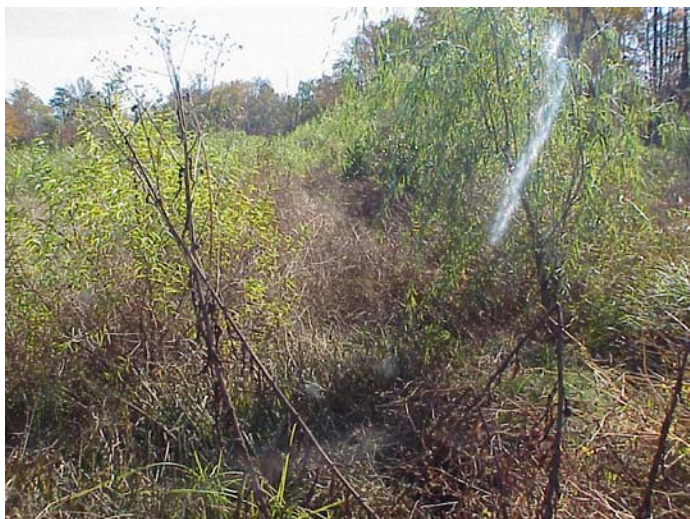
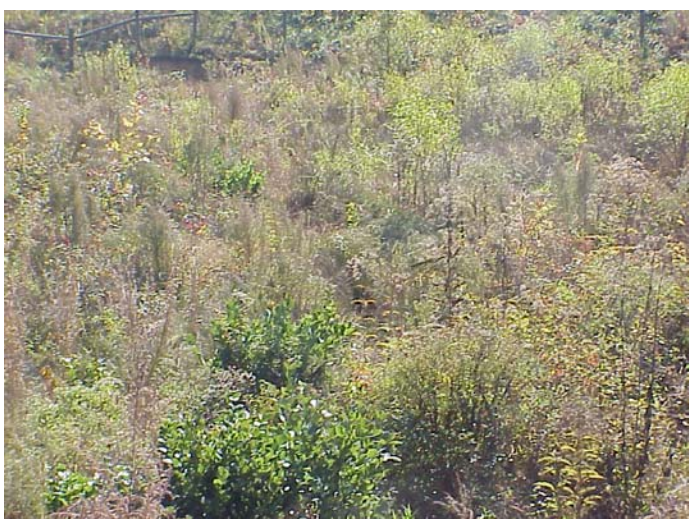
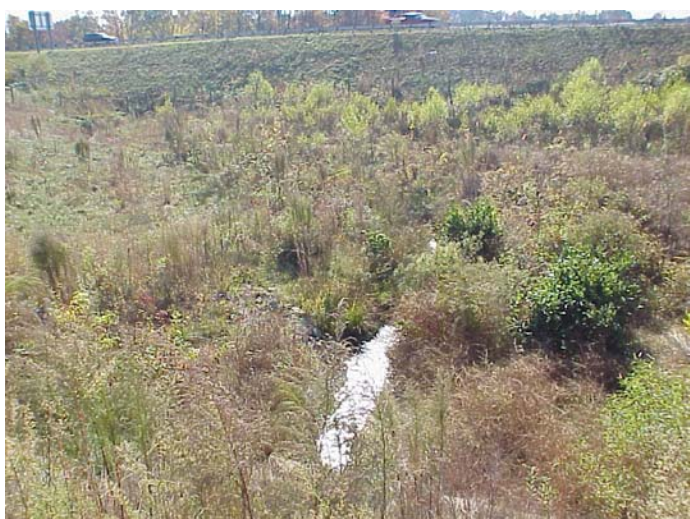
The stream channel was visually inspected during the annual vegetation monitoring of the site. Localized slope problems on the north side of the site (noted in June 2003) are stabilizing with vegetation. The in-stream rock structure on the south side of the site is an old check dam that was partially removed; it does not appear to be compromising the integrity of the stream. The streambanks were stable with herbaceous vegetation cover throughout the majority of the monitored reach. Photos 9 through 16 show the conditions of the stream. No remedial actions are necessary.
